Manhole Inspection Summary

Manhole # S31SS_035MH

Insp Date: **5/14/07 11:48 AM**

Location Address: **2658 HUNTINGDON AVE**

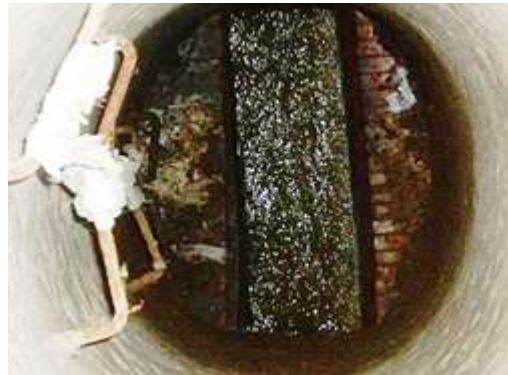
Top View

Bench ☒ Exists Material: **Brick** ☐ Parged ☒ **Debris** (not Condition related)

Steps Count: **10** Missing: **2** ☒ **Corroded**

Surcharge ☒ **Evidence Of Surcharge** Depth: **10** (ft.) ☐ Active Surcharge Present

Corroded steps. Evidence of surcharge - Bench debris.

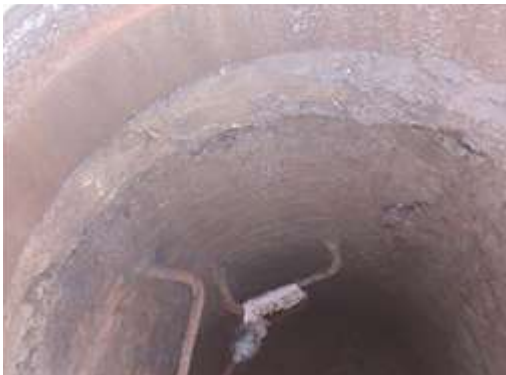
Defect

Frame Offset: **0** (in.) Condition: ☐ Sound ☐ Cracked ☒ **Leaks**

Infiltration: ☐ None ☒ **Joint** ☐ Cracks ☐ Mortar ☐ Roots ☐ Wall

Frame leaks. Adjustment infiltration - other side.

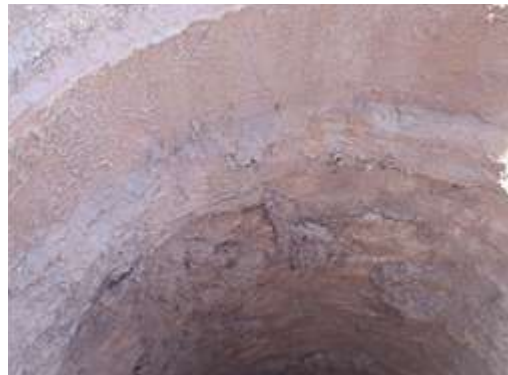
Defect

Frame leaks. Adjustment infiltration.

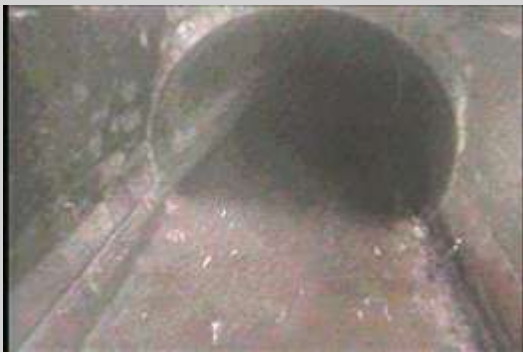
21 in. Circular Gravity Sewer Pipe Out @ 12 O'Clock

Condition: ☐ Sound ☐ Cracked ☐ Root Intrusion ☒ **Deteriorated** ☐ Leaks ☐ Debris

Channel deterioration.
